Falsework Collapse at US Highway 101 (Willits Bypass)
Floodway Viaduct (Br. No. 10-0165)
Contract 01-262004
01-Men-101-R69.4/R78.9

March 9, 2016

California Department of Transportation
Division of Engineering Services
Structure Construction

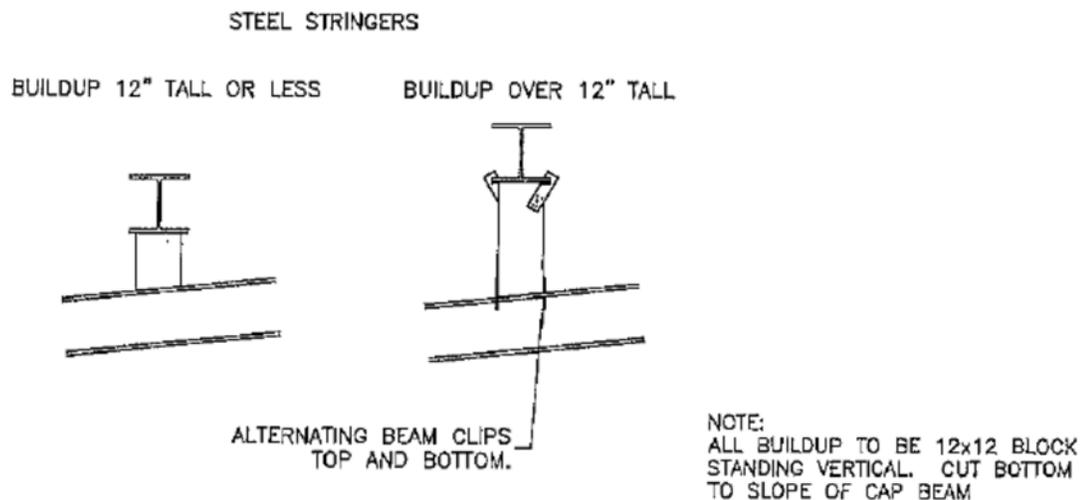
Figure 3: Build-up Connection Details (FD-35)

Stringers in Span 3-5 (HP14 or W14 beams) were connected to the blocks at Bent 3-5 with wood post to cap beam connection (FD-35 on sheet 56 of 59) both to the cap and the stringers as shown in Figure 3.

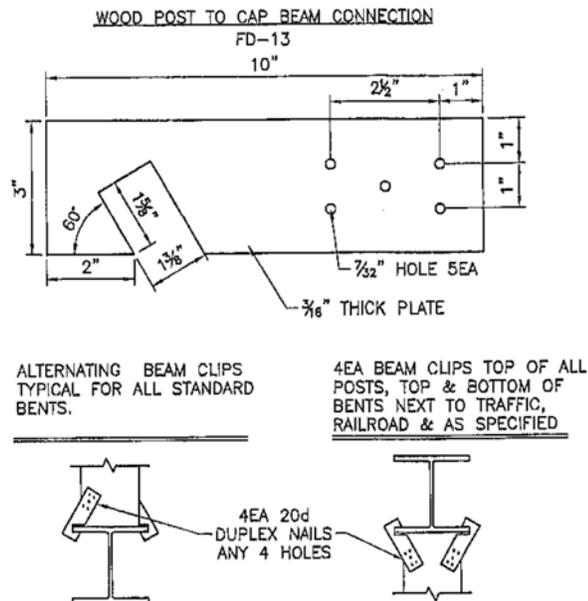
Figure 4: Wood Post to Cap Beam Connection Details (FD-13)

The cap to post connectors (Wood Post to Cap Beam Connection FD-13) (Figure 4) seem to have been adequately installed. They showed varied types of damage. Some were still attached to the wood posts but were twisted, while others exhibited damage as though they had been sheared across the narrowest part of the plate (Photos #44 to 49).

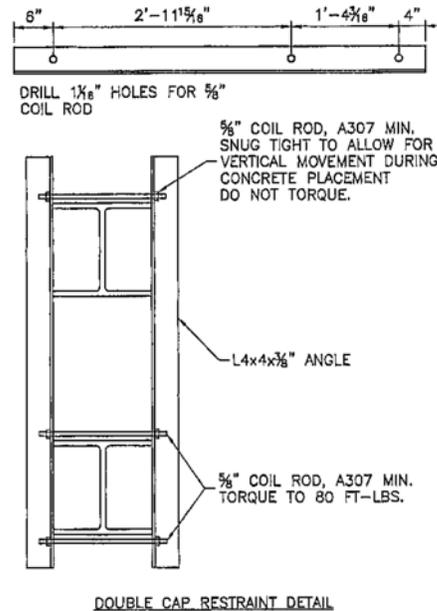
Figure 5: Double Cap Restraint Detail

2. Elements for the “DOUBLE CAP RESTRAINT DETAIL” were not installed on the double sills of Bents 3-4 and 3-5. (Revision 7 Sheet 31 and 31a of 59.) (The Double Cap Restraint Detail can be found in Revision 6 Sheet 57 of 59.) These elements of the double cap restraint were not found in the debris or upon examination of the photos taken prior to pour at Bents 3-4 and 3-5. The double cap restraints as designed were found to be structurally deficient to transfer the load from the top sill to the bottom sill, but as stated earlier they were not installed.

The approved falsework plans called for a “DOUBLE CAP RESTRAINT DETAIL” (Figure 5) at the sills of the falsework at Bents 3-4 and 3-5 that would have provided some external stability. This detail was not installed.

If not properly detailed and constructed stacked structural shapes (double sills or caps) from past experience have been found to be susceptible to displacement from forces occurring during loading of falsework. Double sills rely heavily on being constructed with proper alignment between the members and application of the vertical load through the center of the support. Double cap restraints assist with keeping the top sill beam from moving out of alignment during initial construction and grading of the falsework when jacking operations are performed.

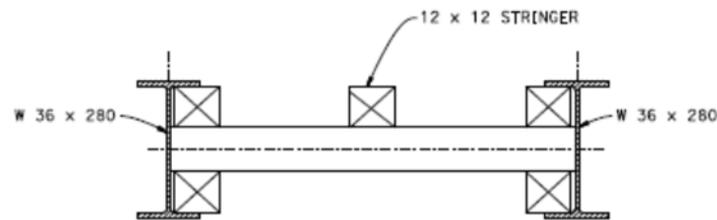
Figure 6: Actual Detail Implemented near Bent Caps

To reduce joist span at the right column of Bridge Bent 4, the contractor modified a detail from the approved falsework plans by using 12 x 12 timber members and wedging them in the tail of the W36 stringers from Span 3-4. The blocking/cribbing shown in Figure 6 was reportedly used. This blocking/cribbing was used as a support for the supplemental stringer built by transverse 12 x 12 timber beams bearing on the 12 x 12 blocking. The detail on Sheet 13 of the approved falsework plans (Attachment #3) lacks the following construction details:

- Member sizes greater than shown were used and no connection details provided. Connection of the 12 x 12 stringer to the column and the blocking/cribbing shown in Figure 6 adjacent to the right column of Bent 4 does not conform to the detail on sheet 13 because the 2 x 4 is changed to a 12 x 12 and a connection to the column is made that is not detailed.
- The length of W36 girder tails from Span 3-4 was not shown on the plans and was not clearly identified to be loaded.
- The blocking was not fully supported as 12 x 12 post dimension is greater than the flange width projecting from the W36 web with fillets and blocking reportedly was not notched to abut against the web.
- This cribbing could become unstable because it was not fully supported over its width. If the 12x12 beam rotated due to load, it may have initiated the unseating of the 12x12 blocking
