Falsework Collapse at US Highway 101 (Willits Bypass)
Floodway Viaduct (Br. No. 10-0165)
Contract 01-262004
01-Men-101-R69.4/R78.9

March 9, 2016

California Department of Transportation
Division of Engineering Services
Structure Construction

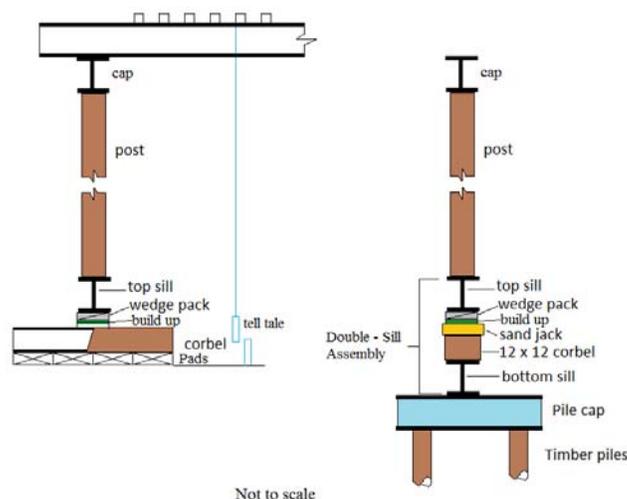
Figure 2: Falsework Nomenclature

Tell-tales were attached to the falsework to indicate any vertical movement due to settlement of the support system which includes pad settlement and joint take up¹¹ between the members. Figure 2 provides a view of tell-tale placement along with the nomenclature used to describe the falsework members for both falsework on pads and piles.
